COASTAL WETLAND PRELIMINARY ASSESSMENT FOR VULNERABLE AREAS AND RESTORATION OPPORTUNITIES AT PORTLAND BIGHT PROTECTED AREA, JAMAICA

Recommendations for Climate Change
Sustainability of Coastal Habitats

Lewis Environmental Services, Inc.

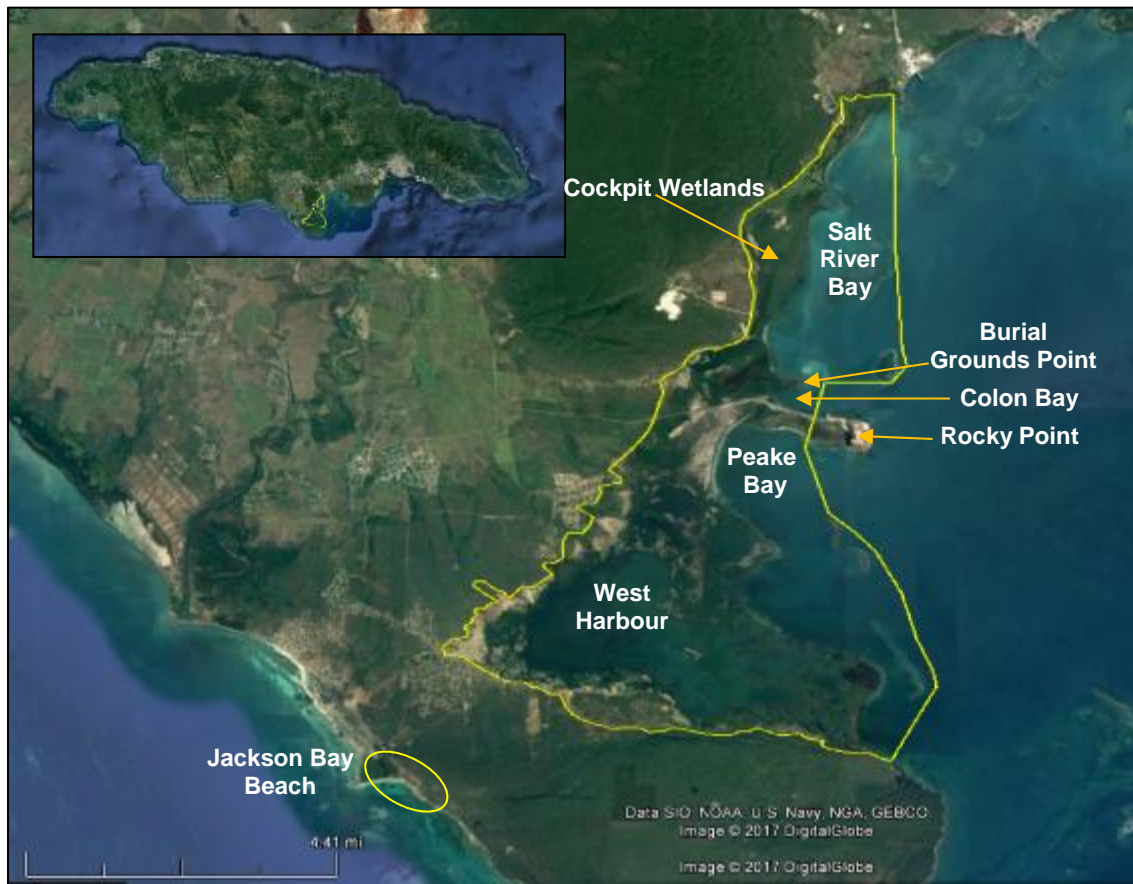
Figure 1. Location and Major Areas of Consideration at Portland Bight Protected Area.

Portland Bight Protected Area (PBPA) and the Cays Ramsar Site, established in 1999, are located along the coastal plain within the southwest quadrant of Jamaica and is comprised of a mosaic of saltwater and brackish water wetland types including, mangrove, scrub mangrove, salinas, beaches and marshland (Figure 1). The area represents the largest remaining mangrove system in Jamaica, encompassing 48 km². These areas provide valuable nesting for several endangered and threatened species including the Hawksbill sea turtle (*Eretmochelys imbricata*), Green sea turtle (*Chelonia mydas*), West Indian Whistling duck (*Dendrocygna arborea*), and American crocodile (*Crocodylus acutus*). In particular, the Salt River, Rolling Bay and West Harbour are three of the most important areas in Jamaica for crocodile nesting. Suitable nest sites are one of the most important limiting factors for crocodile populations. Additionally, PBPA provides nursery and shelter habitat to a large variety of crab, shrimp, and mollusk species and for many fish species, including coral reef fish, which support important local and commercial fisheries. Wading birds foraging along the shorelines and open lagoons also benefit from plentiful invertebrate and fish found within these areas. Vast areas of mangrove and marshland also provide important attenuation of storm energy by protecting shorelines and inland areas from wave erosion and storm surge energy.

The Cockpit Wetlands Area (CSM) is located in the northern portion of the PBPA and is comprised of brackish water wetlands inshore and mangrove forest seaward (Figure 1). Cockpit River to the north, is a spring fed river that is a source of ongoing freshwater flows. A portion of the Cockpit River water is diverted through a canal system that runs the parallel to Salt River Road (Figures 2 and 3). The canal system separates the road and small development areas from the expansive brackish wetland area comprised largely of Phragmites (*Phragmites australis*), cattail (*Typha domingensis*) and sawgrass (*Cladium jamaicense*). Mangrove forests, are expansive in this area and comprised of all three regional species; red mangrove (*Rhizophora mangle*), black mangrove (*Avicennia germinans*) and white mangrove (*Laguncularia racemosa*). Higher elevations support the mangrove associate buttonwood (*Conocarpus erectus*). Three mangrove and beach islands; Long Island, Short Island and Salt Island are located offshore and likely provide benefit to the mainland by attenuating some wave energy during storm events (Figure 3). Long Island and Short Island are surrounded by a vast area of seagrass and coral outcroppings to the east, however, both islands have suffered erosion on the eastern side. Short Island is small with little vegetation and likely to disappear with continued storm events. Salt Island is the largest of the three islands and supports a large interior lagoon. Recent decline of coral reef in this area and the onset of strong storms has produced a phenomenon where dead coral has been piled on the east side of the island creating a natural breakwater.

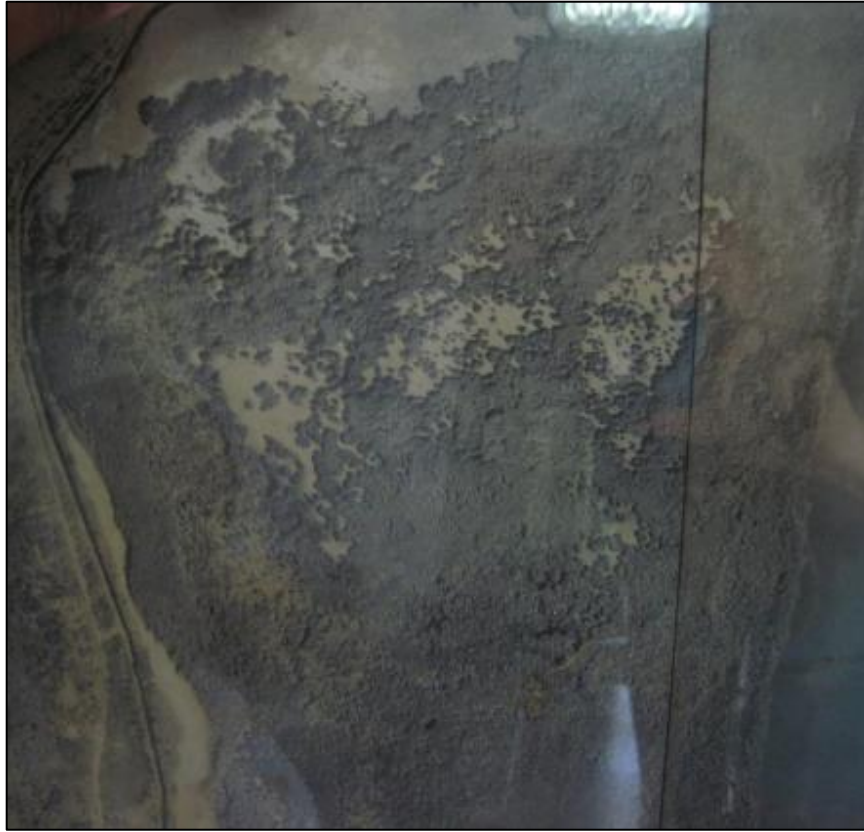
Figure 2. 1950 Aerial of Cockpit Wetlands and Canal System, Photographic Survey Company LTD.

Review of historical 1950 aerials (Photographic Survey Corp. LTD, for the West Indies Sugar Company LTD) (Figure 2) and recent Google Earth imagery indicates this area has largely supported coastal ecological functions and has shown some expansion into the adjacent marshlands. The historical impacts on the area of the damming of the mouth of the Cockpit River, which would have increased the amount of freshwater retained in the wetland, and the more recent partial breach of the dam, have not been documented. However, the diversion of freshwater flows from the canal, a drainage canal located near the center of the area and a road blocking connections to the south have likely have induced some degree of sustained stress on the system (Figure 3). Recent greater than normal rainy seasons and hurricane activity (Charlie and Ivan in 2004 and Dennis, and Emily in 2005, Dean 2007 and Sandy 2012) and severe drought in 2016 have damaged some of the larger trees and evidence of a forest decline is seen in the 2017 Google Earth image (Figure 3). The role of hurricanes in changing the composition of the CSM is undoubtedly significant, however, the marsh areas are also frequently subjected to fires which regularly burn large sections of the wetland and are also likely causes for the expanding area of marsh relative to mangrove or coastal scrub as the grasses recover much faster from fires than the forests and therefore they increase their territory. Fires are frequently deliberately set by persons who fish in the CSM to create and maintain access and possibly to drive out threats from territorial crocodiles.

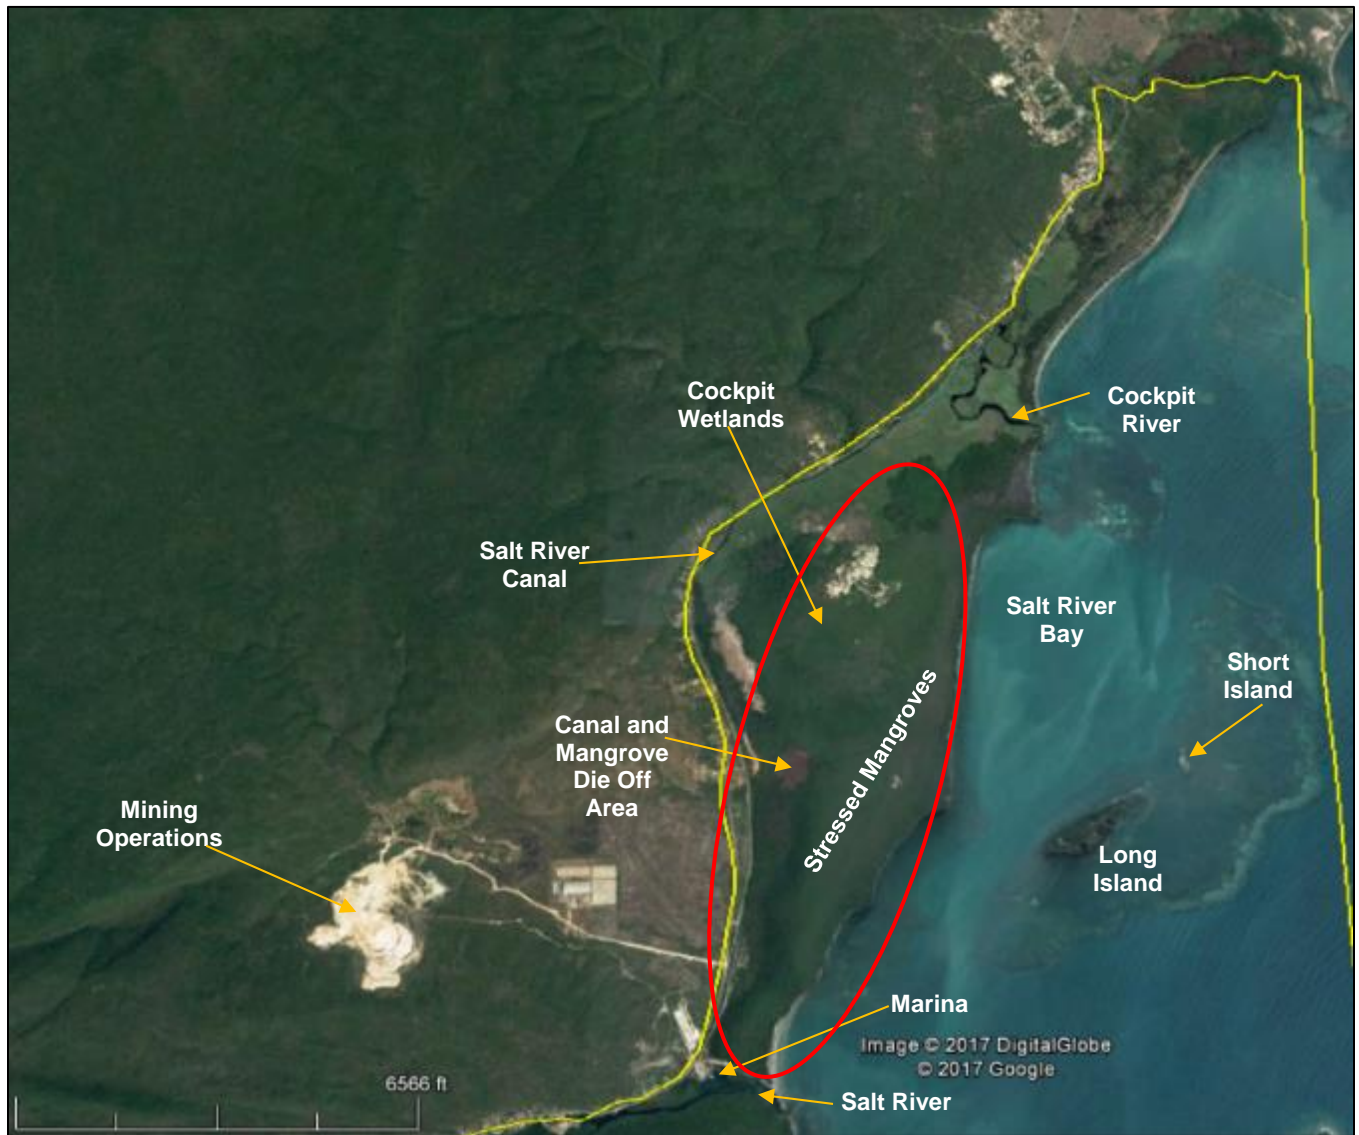
Figure 3. Cockpit Wetlands Major Landscape Features and Stressed Mangrove Area.

This area, is still largely intact and is a priority for further investigation to determine specific reasons for the decline and the feasibility of rehabilitation. The ability to intervene and rehabilitate a mangrove forest before a die off not only saves resources, but is more cost effective, has a greater chance for success and prevents large scale loss of stored carbon, helping reduce the effects of climate change (Lewis et. al. 2016).

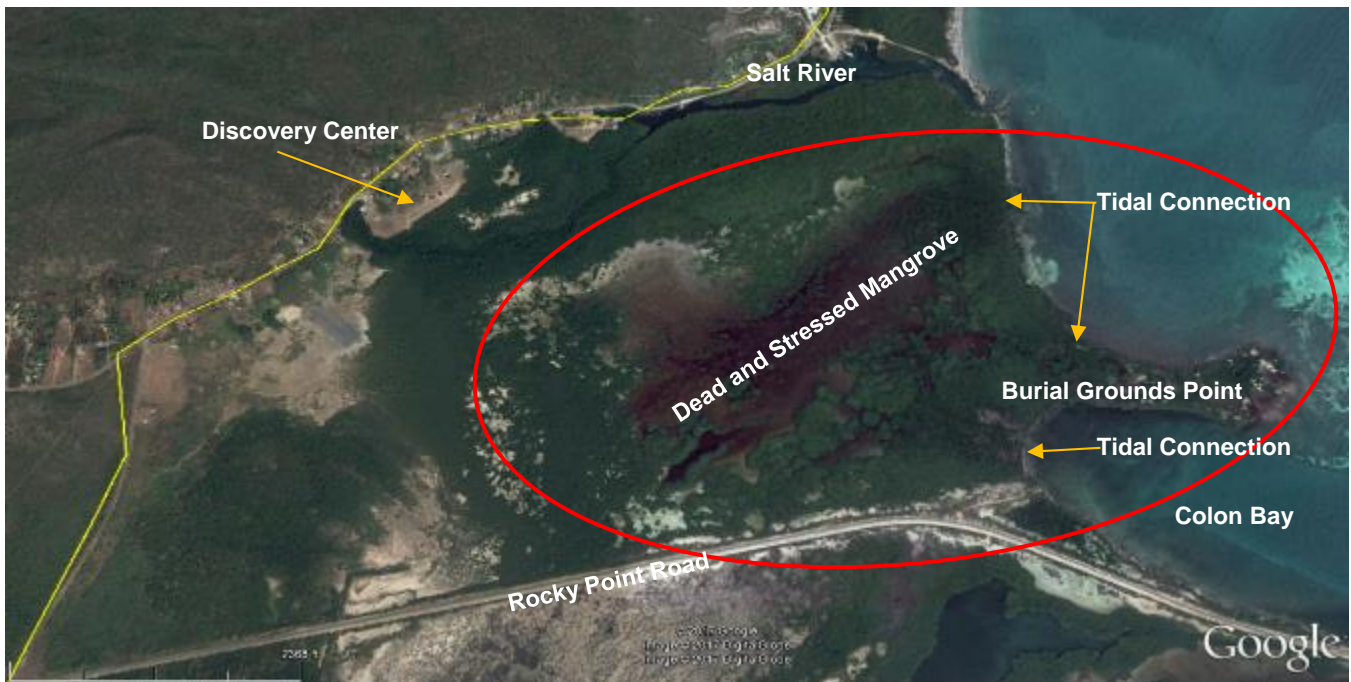
Figure 4. Rocky Point Area, Major Landscape Features, 2017 Google Earth.

The construction of Rocky Point Road and rail tracks did not include drainage systems to allow natural flows from Burial Ground south to Peake Bay, therefore, tidal flow and freshwater runoff discharge are forced through tidal connections at Salt River Bay and another into Colon Bay (Figure 4). These tidal connections are likely in some state of closure, reducing tidal exchange to the interior. In addition, storm events and erosion have breached portions of the coastal berm north of Rocky Point, leading to opening of coastal lagoons to the sea. This combined with sea level rise, is contributing to coastal erosion in some places and has resulted in the loss of important shorebird habitats. The importance of the PBPA for shorebirds was one of the criteria that were used when the Portland Bight and Cays Ramsar site was declared. Since shorebird habitats are increasingly rare in Jamaica and the rest of the Caribbean, a great deal of importance is given to preserving and restoring these areas.

The 2004 Google Earth image shows two tidal connections, with much of the area flooded and void of substantial vegetation (Figure 6). Later that year, Hurricanes Charley and Ivan in 2004, and Dennis and Emily in 2005, changed the hydrology, possibly further reducing tidal flows. By 2006, new mangrove colonization is evident in areas that were historically higher in elevation and represented scrub mangrove and salinas (Figure 7). By 2017, much of the historic scrub mangrove, salinas and mudflats areas that served as important bird foraging area, became colonized by mangrove and areas historically mangrove forest became zones of dead mangrove and impounded waters (Figure 4).

Burial Ground Point has in recent years suffered from severe erosion where storms have impacted the eastern and most vulnerable side of the peninsula. The peninsula has lost approximately 10% - 15% of its 1950 area, based on aerial interpretation (Figures 4 and 5). C-CAM has worked to restore the eroded degraded areas with mangrove plantings. With the work of C-CAM and natural regeneration, the area has developed into a small embayment with mud flats and seagrass meadows providing a mosaic of tidal habitats to support fisheries and foraging for wading birds. However, these areas are very vulnerable to further erosion. It is recommended that continued mangrove restoration efforts and potentially armoring the shorelines with rip rap or constructing an offshore breakwater be considered to help reduce the rate of erosion to this area. It is noted, however, that seagrass meadows are dense and vast in this area and offshore breakwater may not be feasible. Further work to determine the best locations for protective barrier would need to be further investigated.

1. **Rocky Point/Burial Ground Point** (Rehabilitation/Restoration) – Tidal clearing, fill removal, restoring natural hydrologic flows, possibly installing a culvert under Rocky Point Road and conservation and restoration of berms in other areas. Continued work at Burial Ground Point and protective measures considered. Potential New Fortress pipeline impacts/mitigation may affect the hydrology and coordination with C-CAM is critical to ensure the area is not further degraded.

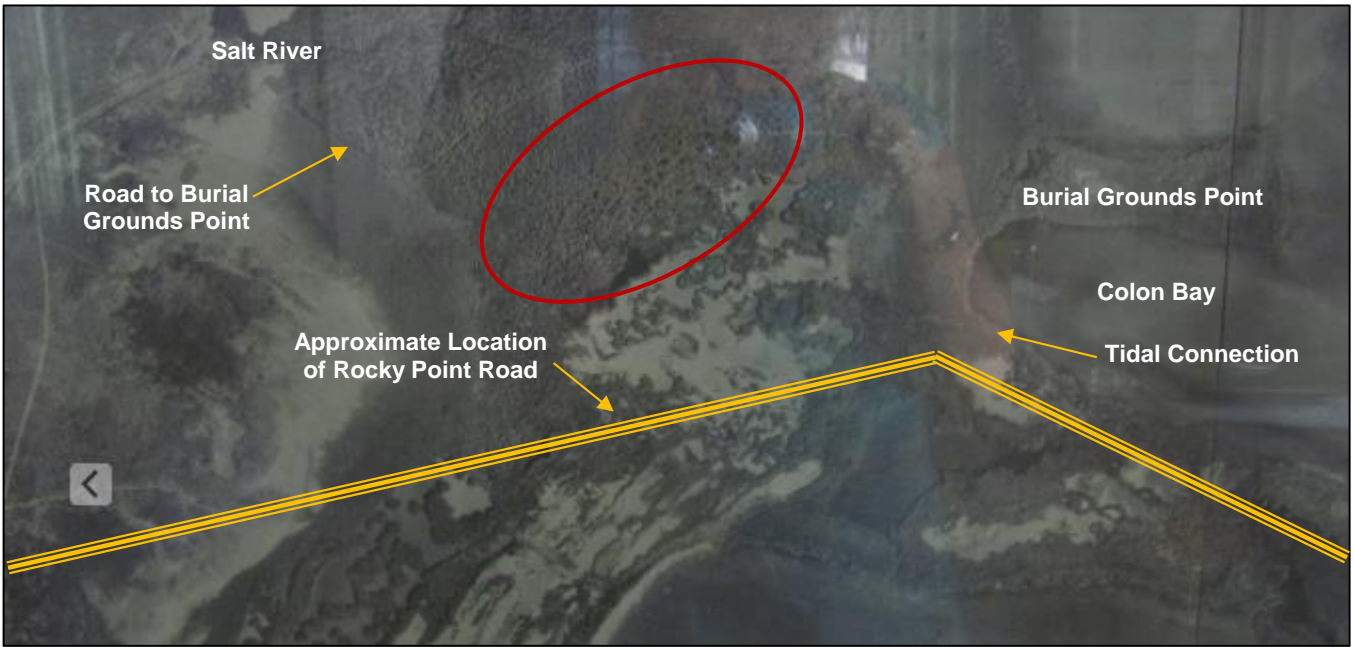
Figure 5. 1950 Aerial Showing Pre-Development Conditions, Photographic Survey Company LTD.

Historical aerials from 1950 show the area pre-development and evidence that Rocky Point Road and rail tracks had blocked those flows to the northern tidal channel and likely impounded some of the mangroves directly to the south as seen in the “pockmarking” of the mangrove forest where the canopy has opened up due to trees dying (red circle) (Figure 5). Closer to the shoreline and roadside, mangroves are intermittent due to higher elevations from accumulations of sands and erosion from the roadside and fringe mangrove forest borders the shoreline.

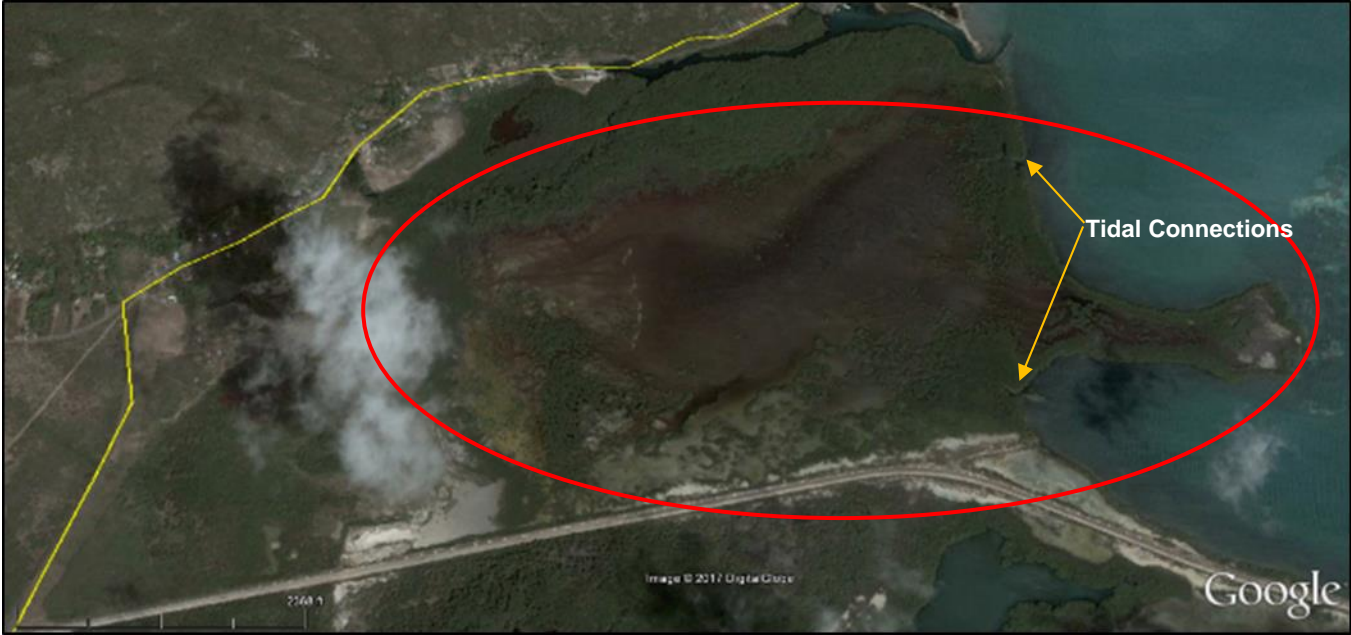
Figure 6. 2004 Google Earth Image Showing Tidal Connections and Extensive Flooding.

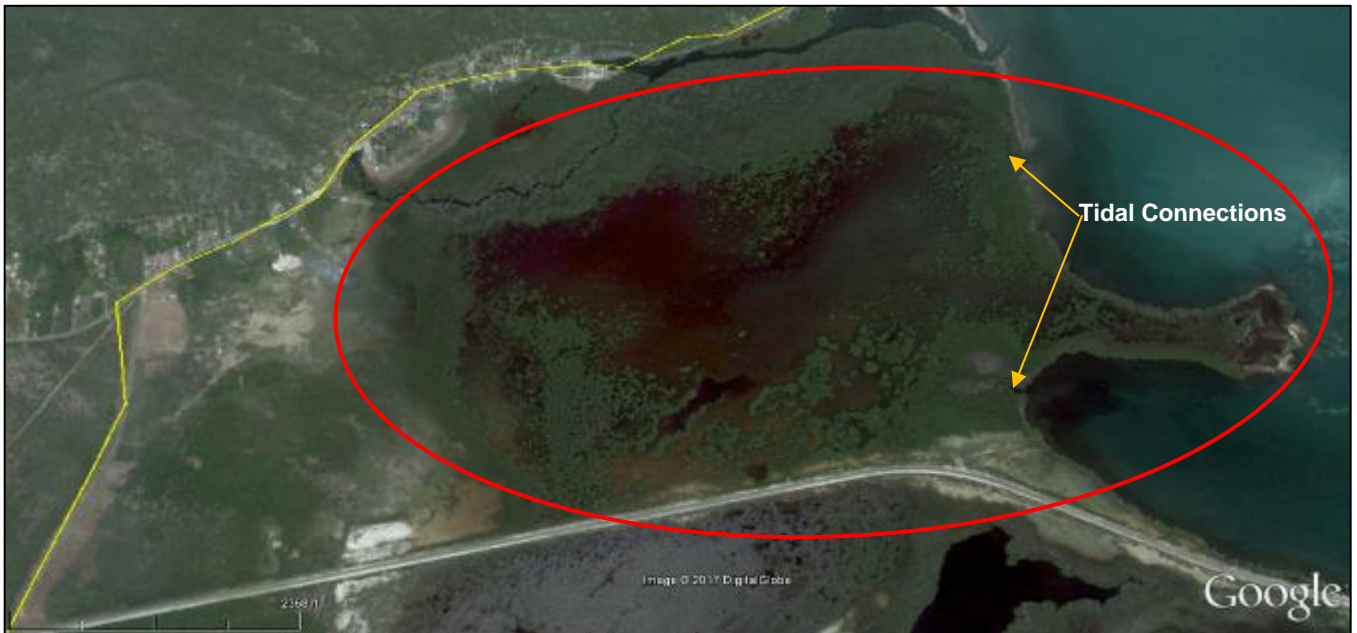
Figure 7. 2007 Google Earth Image Showing Mangrove Recruitment into Higher Elevations.

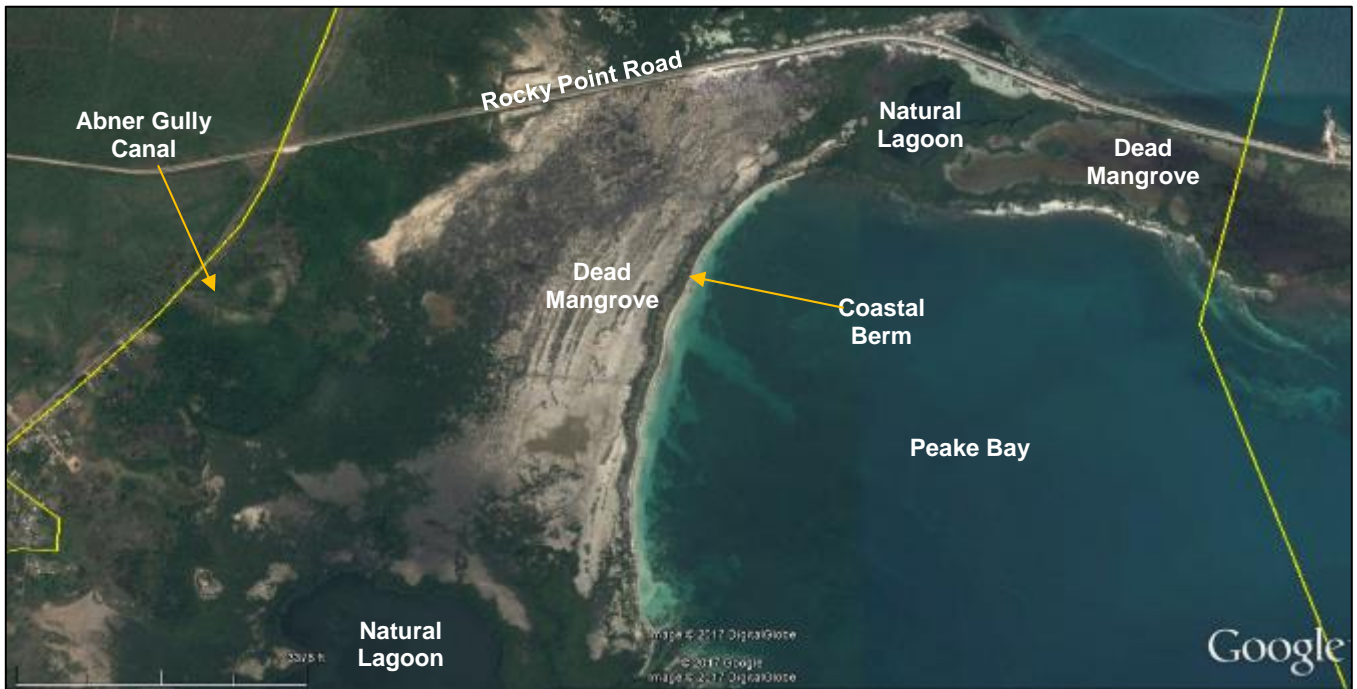
Figure 8. 2017 Google Earth Image Showing Major Landscape Features of Peake Bay Coastal Habitats.

Peake Bay is located just south of Rocky Point has over time shown an overall decline of wetlands and in some cases, periods of mangrove death and recovery. The western side of the wetlands is bordered by Salt River Road and the outer reaches of Mitchell Town and the north side is bordered by Rocky Point Road and rail tracks. The general landscape is largely basin mangrove forest and natural lagoon areas. Higher elevations are found closer to the shoreline created by accumulation of sands (beach bars) from storm events, and currently is an expansive area of dead mangrove of approximately 154 ha (Figures 8 and 9). An impervious coastal berm along the eastern shoreline prevents routine tidal exchange to the majority of the area. The large lagoon system that borders the south end does not appear to have major influence on the area (Figure 8).

The 1950 aerial shows this area sparsely vegetated, however it cannot be interpreted if this is due to dead mangroves not visible in the image, or is in fact less mangrove (Figure 10). It is possible that the area suffered damage from the 1951 Hurricane Charlie followed by Hurricane Hazel 1954 and Hurricane Janet 1955. The Google Earth image from 2004 (Figure 11) shows this area mostly revegetated prior to impacts from Hurricane Ivan. The area again shows areas of major die off in 2006 after four major hurricanes (Charley and Ivan in 2004 and Dennis and Emily in 2005) (Figure 12). Recently Hurricane Dean in 2007 and Sandy in 2012 passed over the area and leaving little time for any significant recovery (Figure 8).

6. **Peake Bay** (Restoration) – Restoring natural tidal connections, installation of culverts under Rocky Point Road. This area appears to be uniquely sensitive to storm events and restoration may be limited by an increase in storm intensity. A significant amount of investigation will need to be completed prior to finalizing any restoration plan.

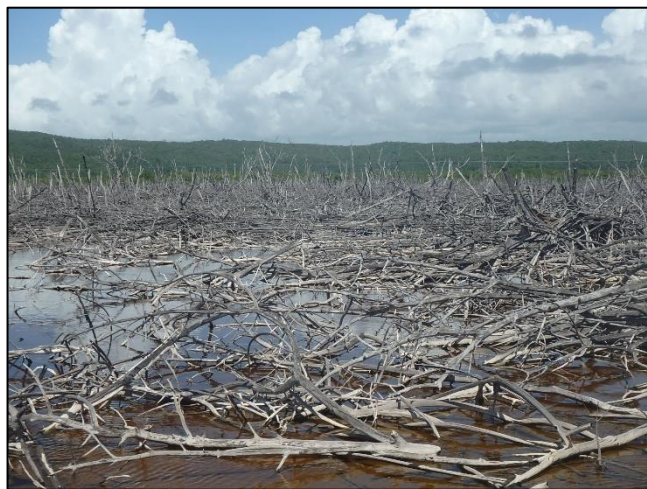
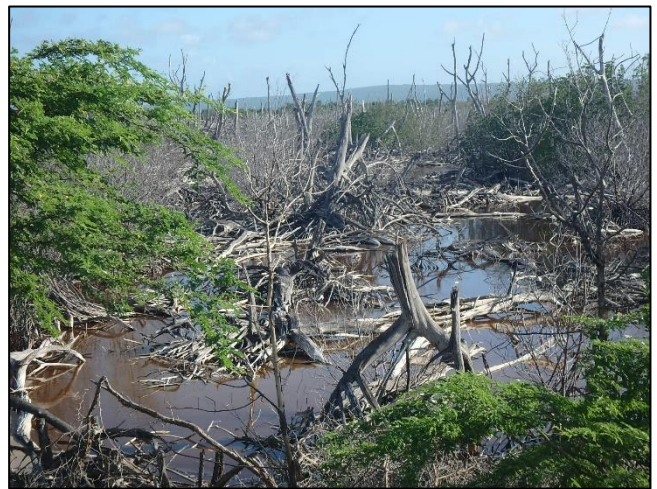
Figure 9. Photographs of Peake Bay Dead Mangrove Area, October 18, 2017.

There are opportunities for restoring this area by re-establishing historic tidal connections. This would include the installation of culverts under Rocky Point Road and allowing freshwater drainage from the old Abner gully canal to be redirected to a purposeful location. It should also be noted that it is possible that the mangroves along the western shoreline of Peake Bay present a unique situation where they may also have a natural cycle of die off and recovery from major storm events.

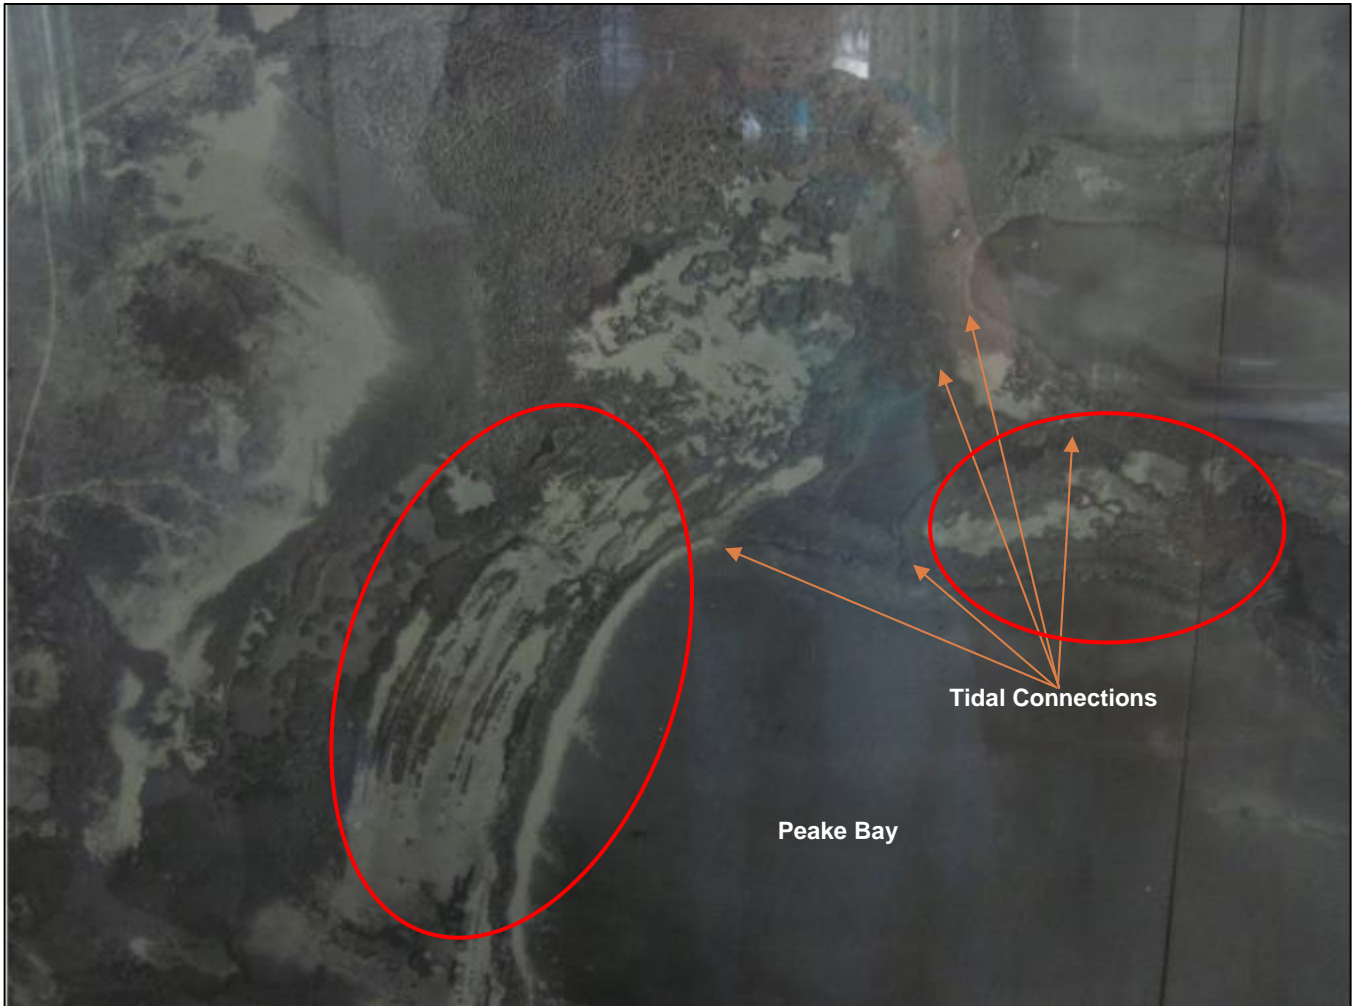
Figure 10. 1950 Aerial Showing Historic Conditions and Major Tidal Connections, Photographic Survey Company LTD.

Based on photointerpretation of the 1950 aerial, Peake Bay tidal exchange was contiguous with the Rocky Point/Burial Ground system and represented a well-developed high canopy mangrove forest. Three significant points of tidal connections were present, all of which are now blocked by Rocky Point Road and rail tracks.

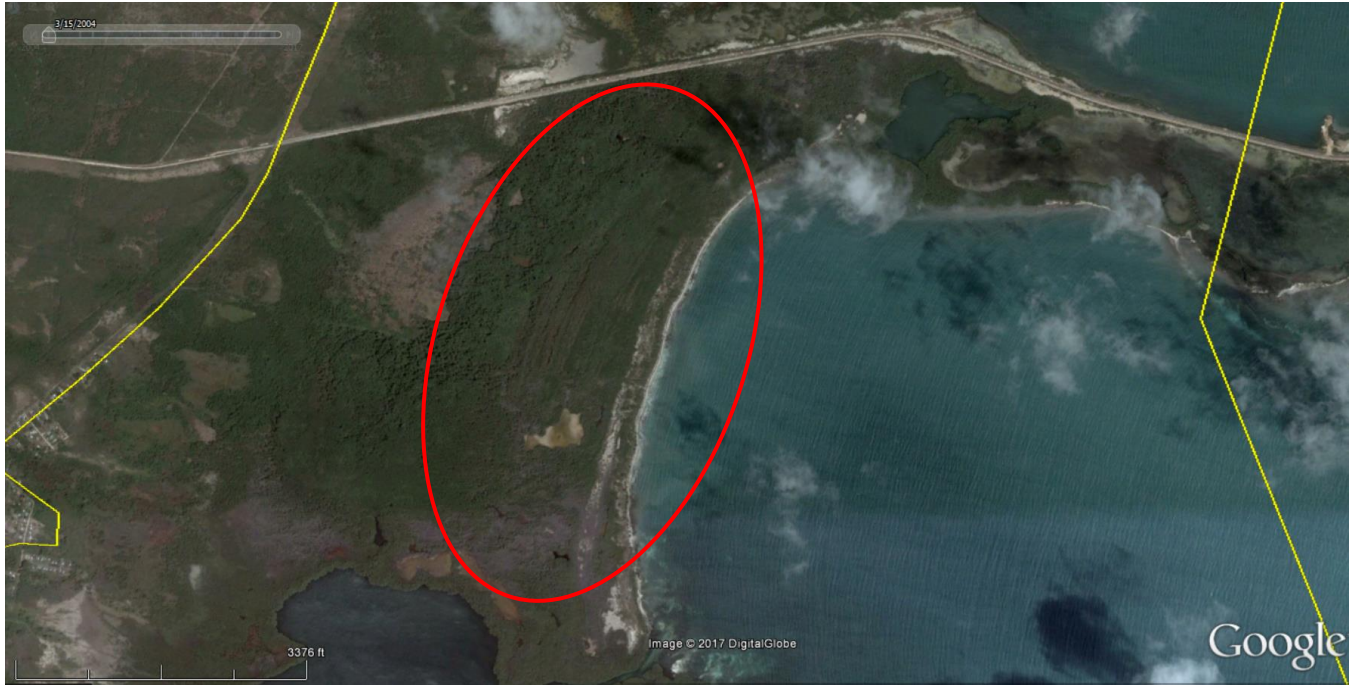
Figure 11. 2004 Google Earth Image Showing Recovery of Mangroves.

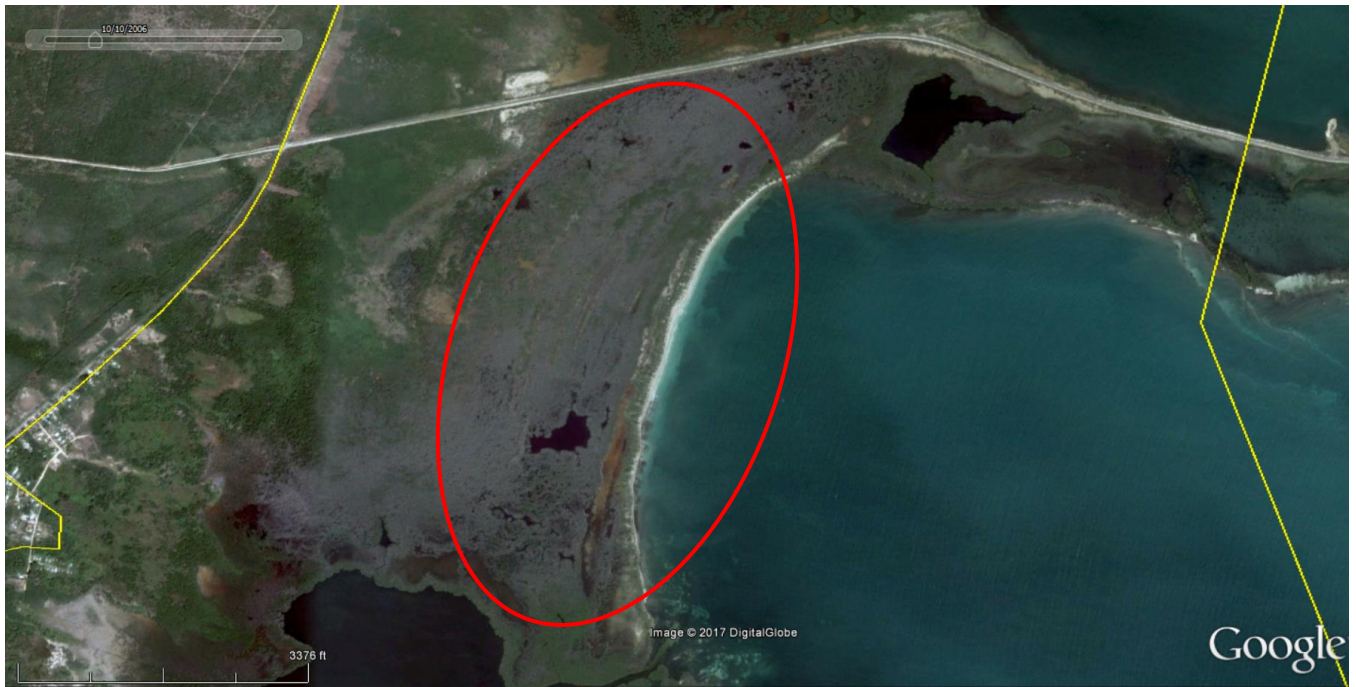
Figure 12. 2006 Google Earth Image Showing Major Mangrove Die Off.

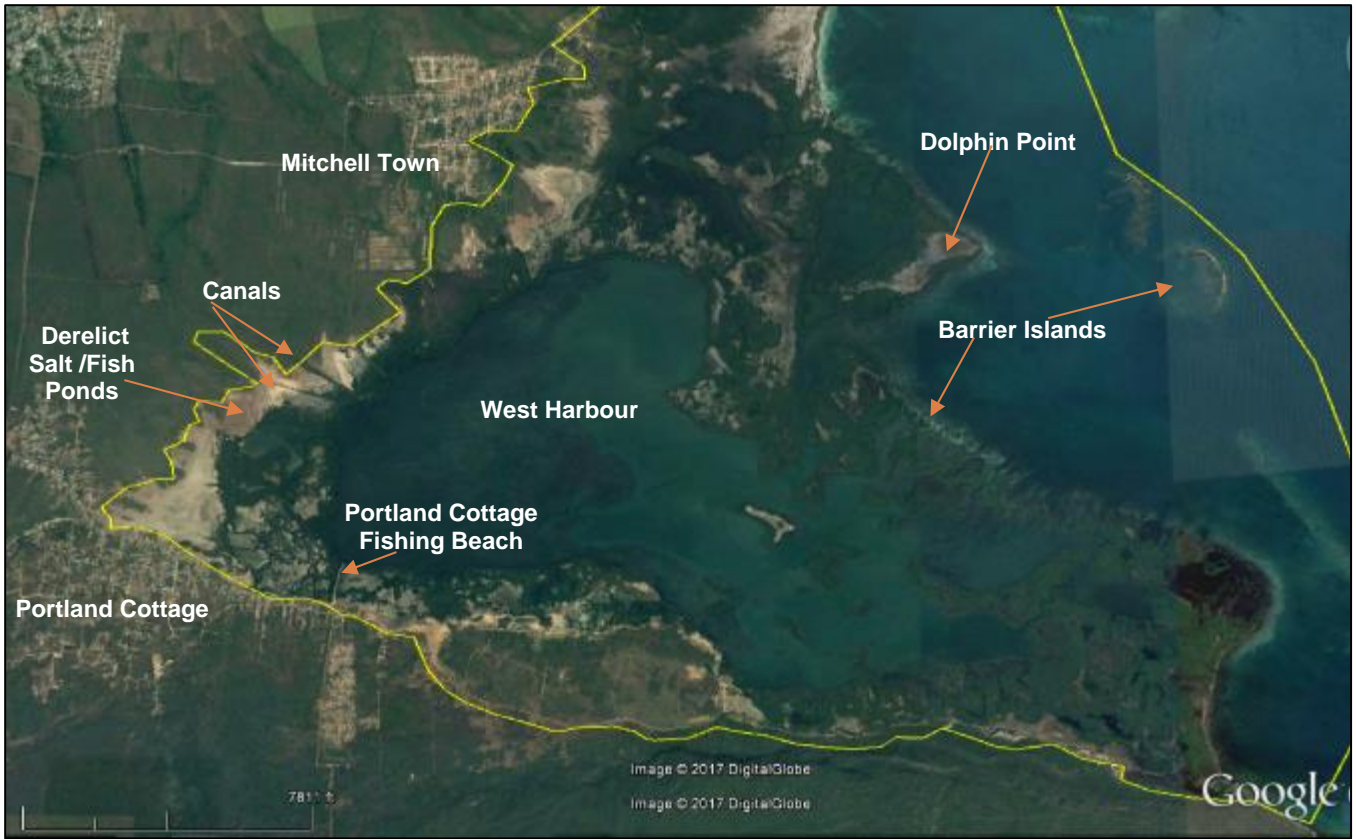
Figure 13. 2017 Google Earth Image Showing West Harbour Major Landscape Features.

The outer barrier islands are important to the sustained health of the harbor (Figure 13). The barrier islands help attenuate wave energy during high winds and provide important sanctuaries for a variety of shorebird species. Although the majority of the barrier islands are intact, the outer most islands are currently void of vegetation and are vulnerable to degradation. It is recommended that these islands be evaluated for the possibility of reinforcement using rip rap or something similar and planted if possible. C-CAM has worked to plant the outer islands, however strong waves and winds impede successful plantings. Potentially adding rip rap to help attenuate wave energy with continued plantings may provide benefit to the islands.

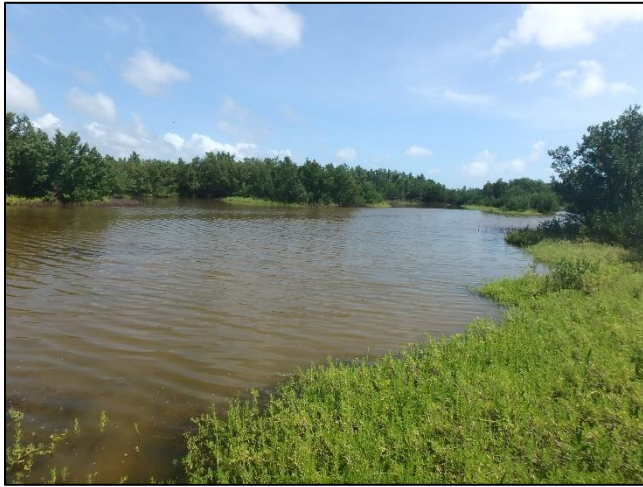
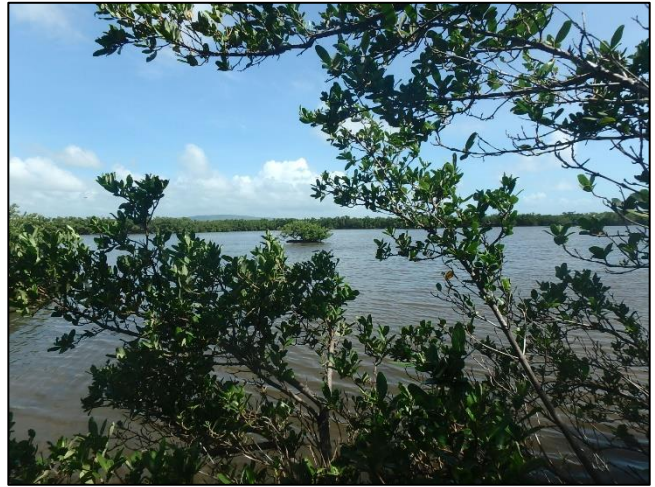
Figure 14. Photographs of Natural Lagoon Areas, West Harbour, October 18, 2017.

West Harbour encompasses the southern portion of the PBPA. Mitchell Town and Portland Cottage border the northwest and southwestern outer boundaries. Barrier islands to the east provide some protection from wind driven storms. The entirety of the shoreline is a mosaic of extensive salinas, mangrove forest and natural lagoons with most of the major tidal channels seemingly intact and functioning. The mangrove forest is intertwined with connecting open lagoons providing important nursery habitat for fisheries, bird foraging and crocodiles (Figures 13 and 14). However, some areas now open are the result of mangrove loss, possibly a combination of storm damage, recent greater than normal rainy seasons, and anthropogenic influences.

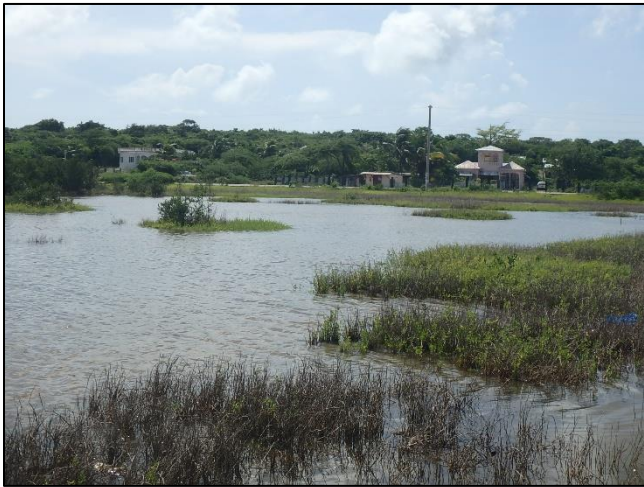
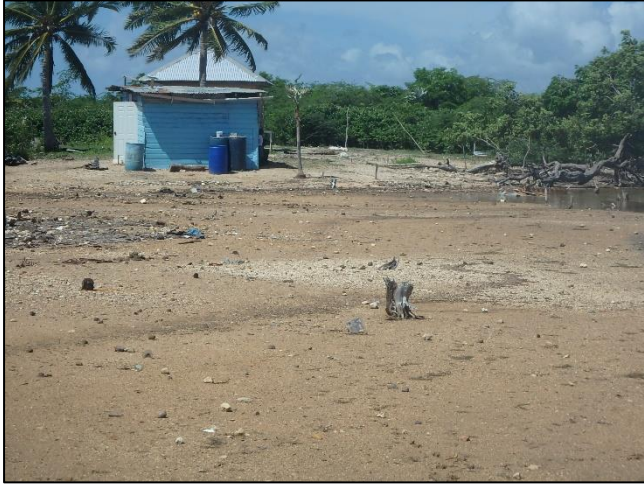
Figure 15. Photograph of Encroachment into West Harbour Wetlands, October 18, 2017.

Anthropogenic alterations to the hydrology, encroachment into the interior wetlands and wood harvesting has introduced stress on the system resulting in areas of mangrove and salinas loss (Figure 15). The dependence on fishing, access to fishing areas, harvesting of mangrove for wood, grazing and dredging of drainage canals are challenging socio-economic influences that are difficult to address.

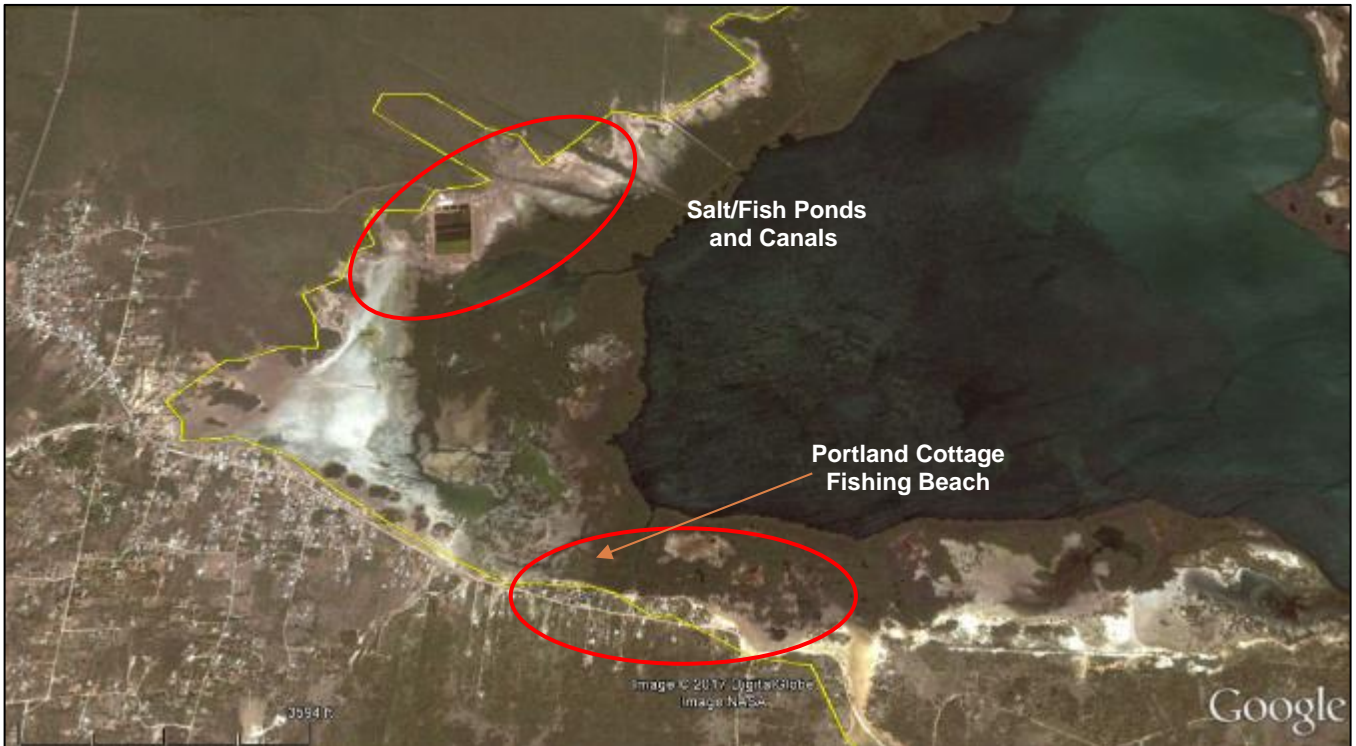
Figure 16. 2002 Google Earth Image Showing Areas of Interest.

The 2002 Google Earth image (Figure 16) shows conditions of two areas of interest during active salt/fish pond activity and pre-filling of the Portland Cottage fishing beach. These areas were significantly altered by cutting of canals and ponds and casting material aside creating berms and blockages to the natural hydrology. This is evident in the die off of mangroves adjacent to these activities. In 2004, the Portland Cottage fishing beach was filled to allow better access to open waters of West Harbour (Figure 17). This exacerbated the problem by further blocking tidal exchange. In addition, hurricane damage and continued wood harvesting continues to thin the forest.

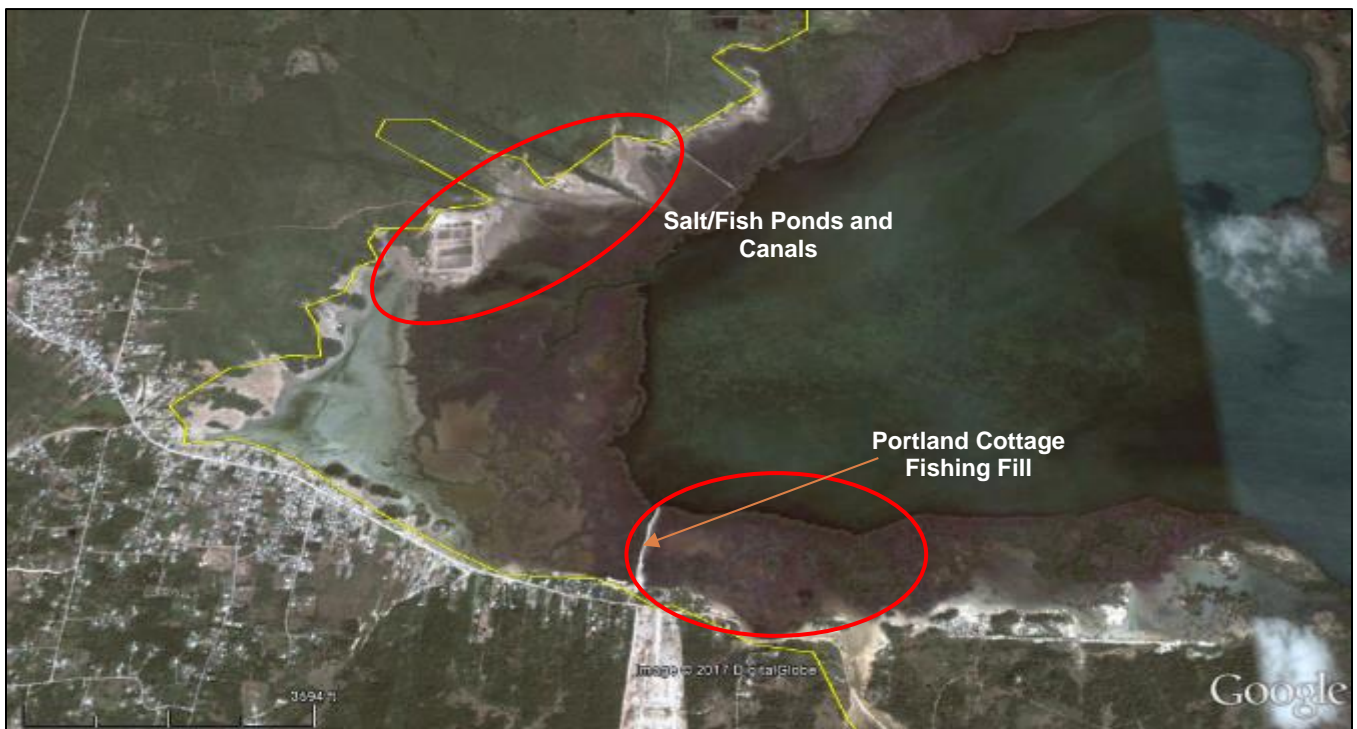
Figure 17. 2005 Google Earth Image Showing Areas of Interest and Severely Stressed and Dead Mangrove Forest.

The second area of interest is an area highly disturbed by the construction of salt/fish ponds and canals. The disturbance has resulted in an area of mangrove die off and disturbance of salinas providing little to no habitat function (Figures 17 and 19). Removal of barriers and re-grading of the site would be necessary for restoration. Since this area is entirely open, many options are available to restore habitat for specific species such as crocodile nesting areas or hypersaline areas suitable for brine shrimp to encourage Flamingo use. Additional investigations and survey work would need to be completed to evaluate the complete restoration feasibility of this area.

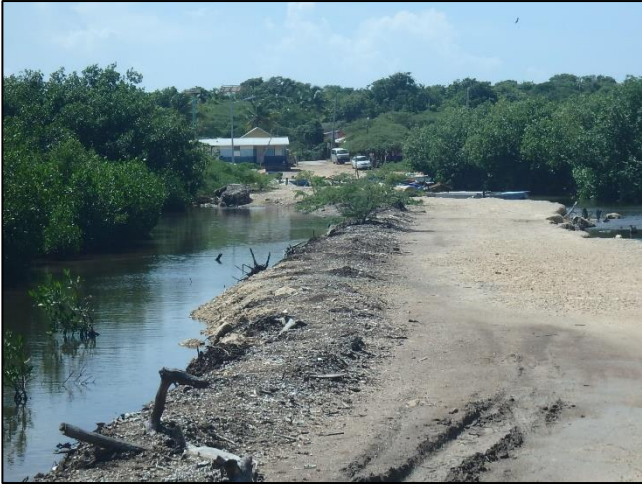
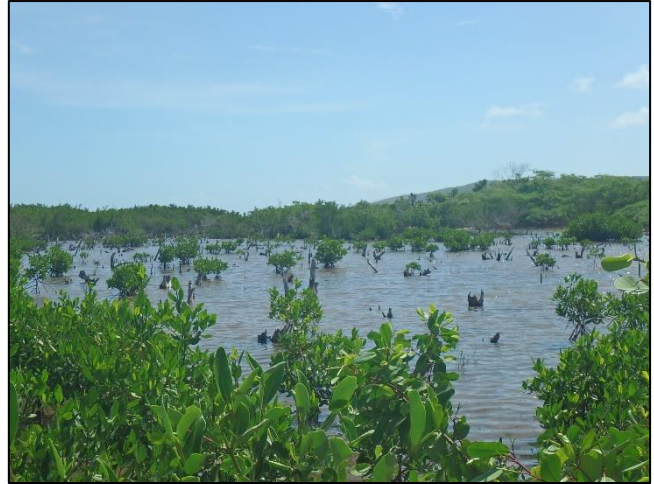
Figure 18. Photographs of Portland Cottage Hydrologic Restoration and Recovery, October 18, 2017.

Recent efforts by NEPA and C-CAM to educate residents at Portland Cottage fishing beach and implement a local mangrove restoration projects by re-establishing the hydrology has proven successful in the revegetation (both planted and natural recruitment) of approximately 5 ha of mangrove (Figures 18). Additional work to remove blockages in the system will further increase the area of recovery. However, other stressors such as grazing by goats and socio-economic needs of wood harvesting, encroachment and filling of paths continues to be a difficult challenge that will require ongoing education and support of the community.

4. **Portland Cottage Fishing Beach** (Rehabilitation/Restoration) – In progress -Continued removal of blockages for restoration of areas to the south
5. **Cockpit Wetlands** (Rehabilitation) – Tidal clearing, restoring natural hydrologic flows to the north

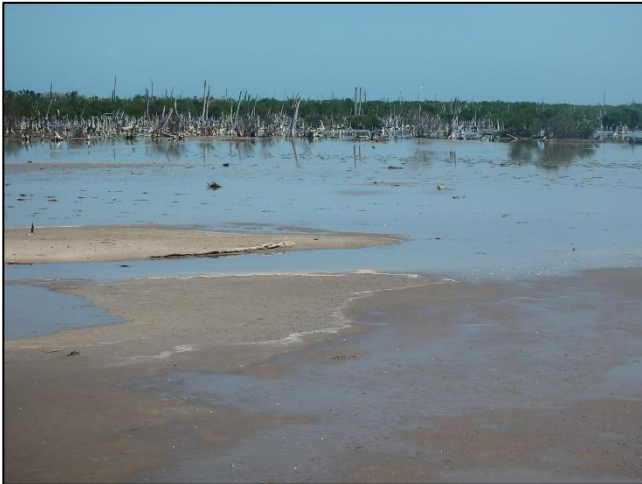
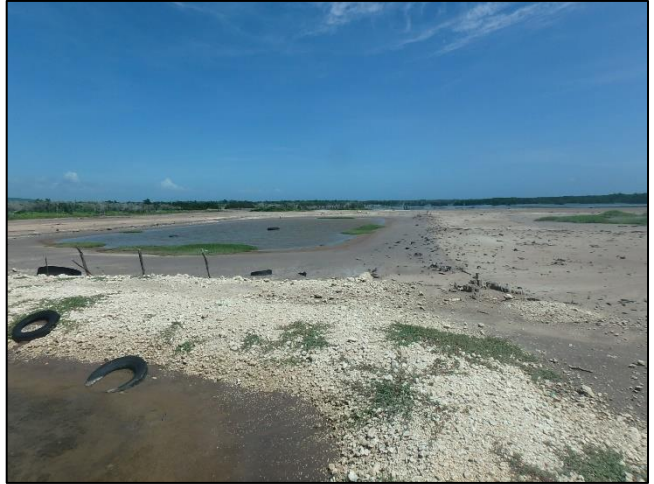
Figure 19. Photographs of Dead Mangrove and Salt/Fish Ponds at West Harbour, October 18, 2017.

2. **Jackson Bay Beach** – Install culverts under road and potential channel clearing.
3. **West Harbour Salt/Fish Pond** (Restoration) – Regrading and removing blockages to restore natural hydrology. Reinforcement and continued planting of the outer islands.
