COASTAL WETLAND PRELIMINARY ASSESSMENT FOR VULNERABLE AREAS AND RESTORATION OPPORTUNITIES AT PORTLAND BIGHT PROTECTED AREA, JAMAICA

Recommendations for Climate Change
Sustainability of Coastal Habitats

Lewis Environmental Services, Inc.

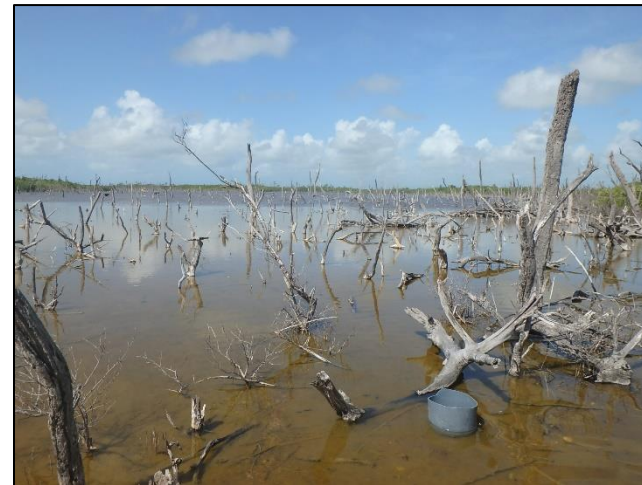
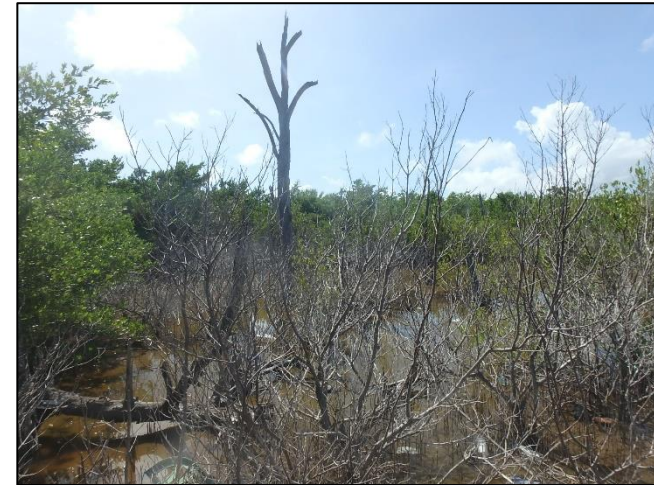
Figure 20. Photographs of Dolphin Point Natural Mangrove Die Off, October 17, 2017.

Other areas of interest that were visited were Dolphin Point, the outer barrier islands and Jackson Bay Beach (Figures 1, 13, 20 and 21). After further historical review of Dolphin Point, the mangrove die off area appears to be a natural feature, where during times of drought, mangroves will re-colonize and then die off during rainy years and storm events. The size, shape, persistence and lack of any obvious stressor indicates this is a natural phenomenon of this area. Other areas nearshore and similar to Dolphin Point may be present, however without additional field investigations this cannot be verified.

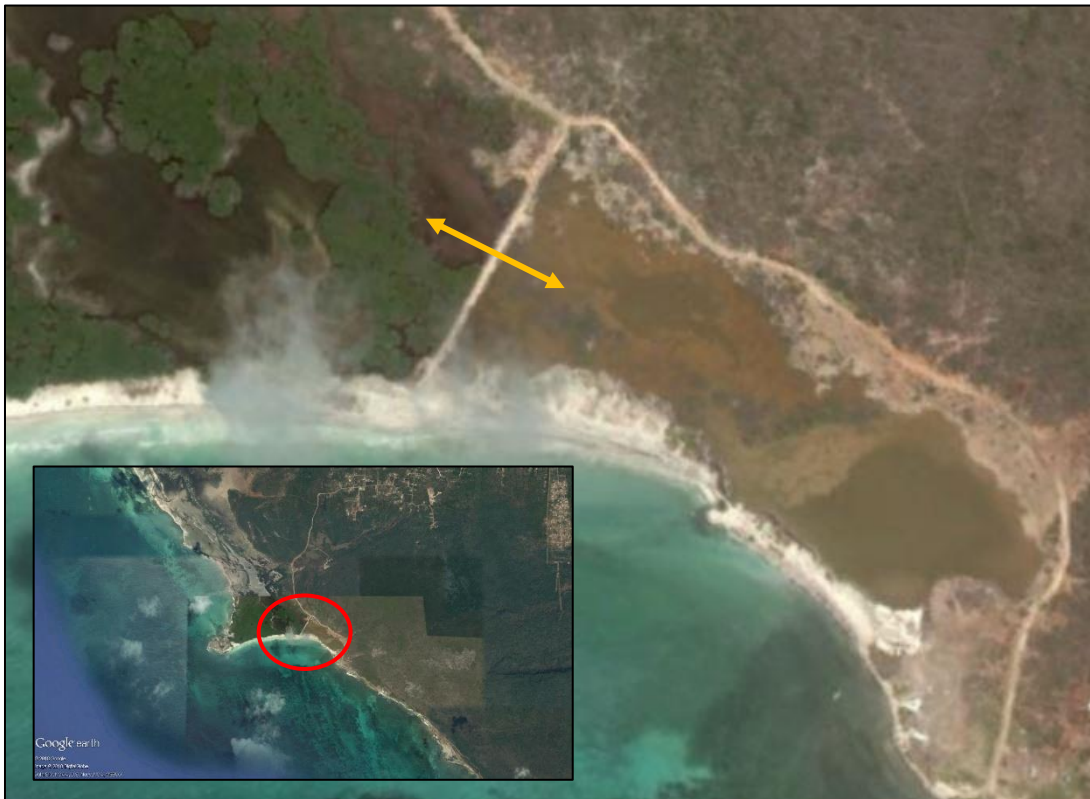
Figure 21. Location of Jackson Bay Beach and Mangrove Die-Off Area.

Jackson Bay Beach is experiencing massive mangrove die off from road construction blocking natural flows and drainage. In particular, the area to east of the main road to the beach is completely dead (Figure 21). Installation of culverts under the roads and potentially some clearing of channels that have accumulated sediments and debris from reduced flushing will likely facilitate natural recovery to the area. This area is a priority for restoration efforts.

2. **Jackson Bay Beach** – Install culverts under road and potential channel clearing.
3. **West Harbour Salt/Fish Pond** (Restoration) – Regrading and removing blockages to restore natural hydrology. Reinforcement and continued planting of the outer islands.
